## Tests Août 2004

### Avant installation définitive

### Avec Slow Control Epics + Minidag LabView

### Pas de polarisation HT – Une seule face lue à la fois.

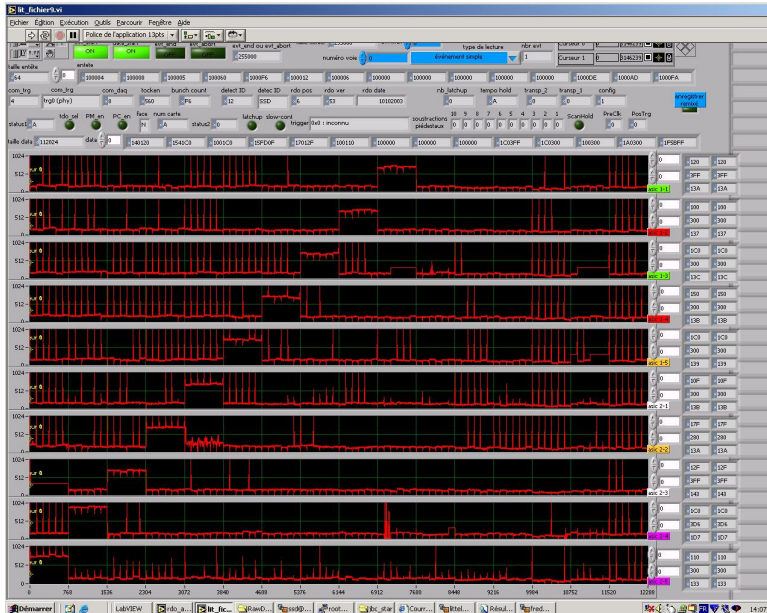
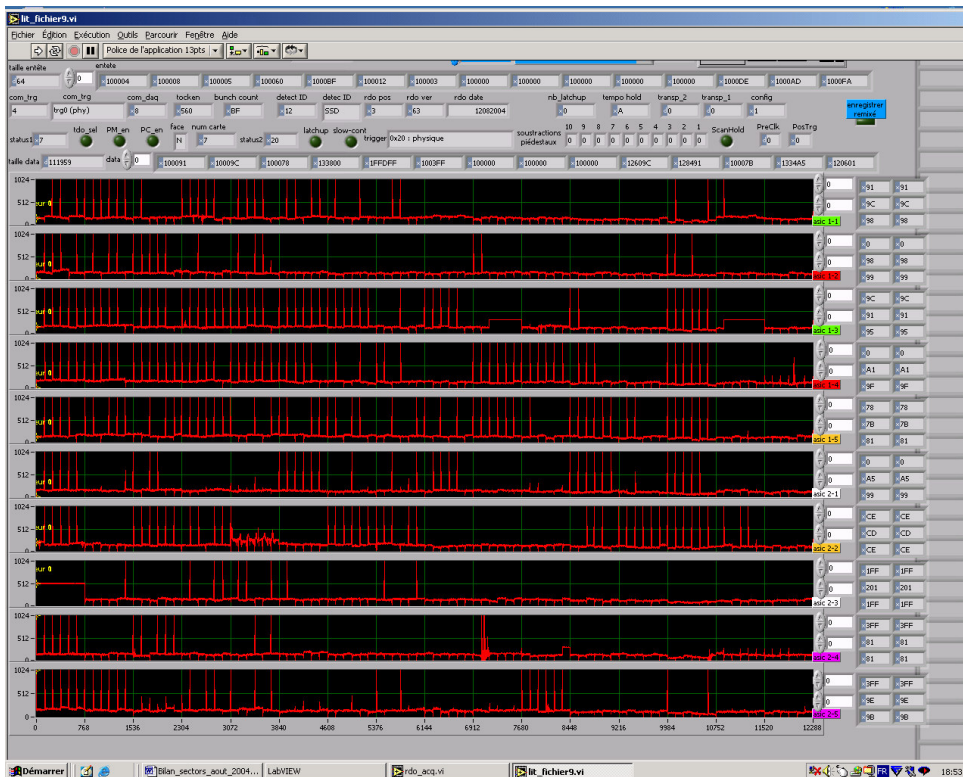
## Sector 1N (ladder 1N to 10N)

No problem. C9 to C16 bypassed.

No big problem. A noisy area on H10. A6 missing on H11. Still missing when the bias parameters are modified.

C1 bypassed. H1 missing. Everything else OK. H1 still missing even with the force bias.

H1 with a noisy area. H5 has a very bad pedestal. C5, C10 and C16 bypassed.

Everything OK.

Everything OK except H15 with some missing chip (A1,A4 to A6). H15 OK (except A1) when the bias parameters are modified.

C1, C2, C4 and C8 bypassed. H15 with some missing chips. H15 ok when the bias parameters are modified.

H10 with 4 a128 missing. 5 a128 are seen when A3 is bypassed.

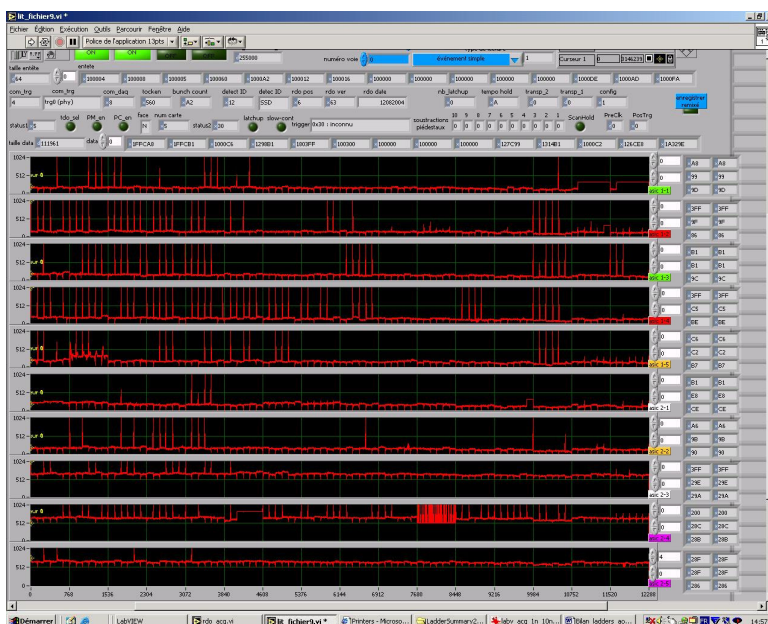
## Secteur 2N (11N à 20N)

All the ladders are present. The three last ladders (18,19,20) ie the ones at the end of the SCSI cable do not get their pedestals in the right range but at a value equal to the pedestal+512. We understood that this was due to a bit missing in the data from those ladders. It seems to be temperature dependant. When cold (and cool down) their pedestals are at the right place. If the pedestals jump again, we can use the offset subtraction in the read out boards.

H15 and H16 show only the two first chips. Bias parameters changed for all the chips on these hybrids (Ipreamp=80 instead of 100 and Ishap=50 instead of 60)

No big problem. The chip A6 on H15 is not seen. It is back when the bias parameters changed for all the chips (Ipreamp=80 instead of 100 and Ishap=50 instead of 60)

H2 has some problems : bad pedestal and bigger than 255. We disconnect and plug back the bus in the Hirose connector : no change...

H6 has only 5 a128 chips !

The pedestal of the full ladder has some time an offset of 512 adc counts.

H11 is some time not responding (pedestal=512+/- 1). It is always ok when it is the only ladder on the SCSI cable. It is bad when the ladder 19 is on the same SCSI cable.

The A3 of H6 does not give any signal. When cold the hybrid gives 5 chips. When hotter, the hybrid gives less chips (A3 been always absent).

The H11 is consuming lots of current (it triggers the latchup detection) and does not give any good pedestals. Putting the chips bias to zero sets the bias at zero for the previous hybrid (H12). When alone on the SCSI cable, the H11 has is pedestal at 512.

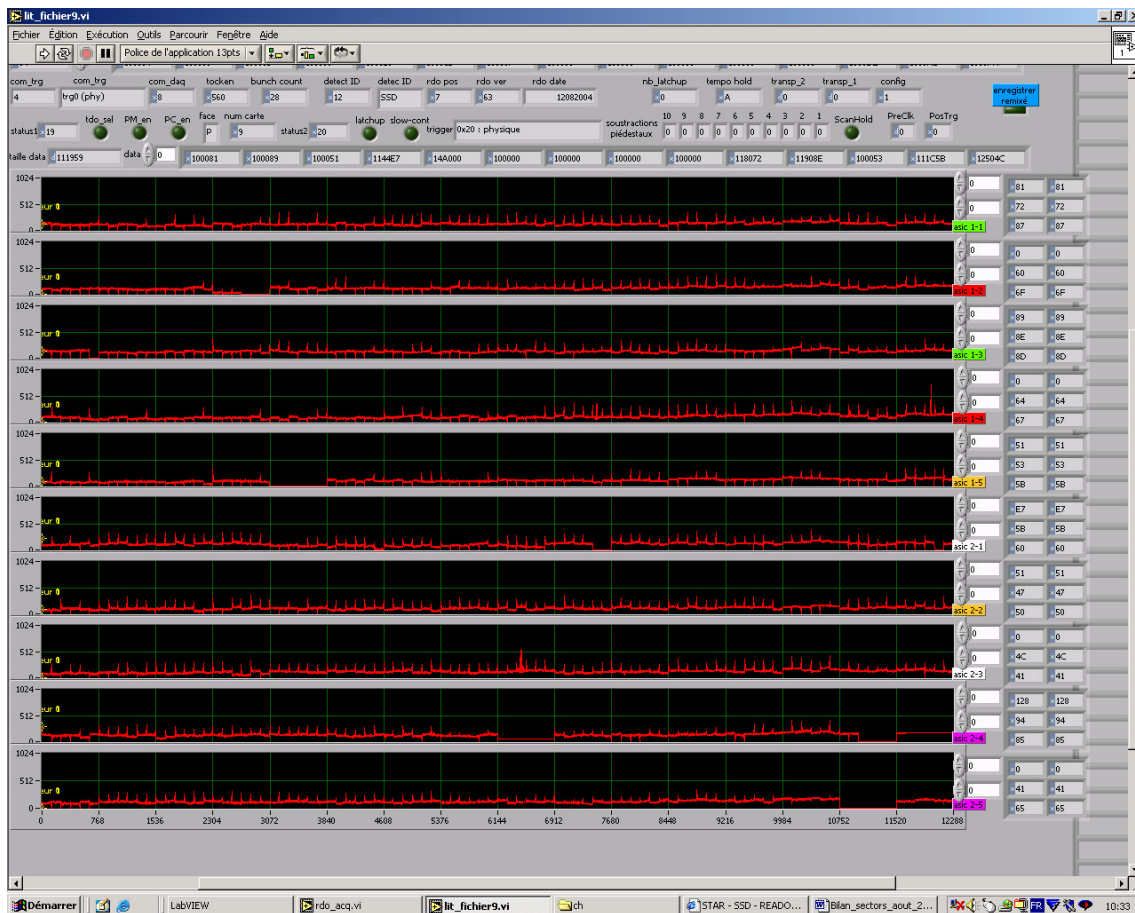
## Sector 2P (Ladders 11P to 20P)

Everything OK except H4 (A4 to A6 absent). A4 bypassed on H4. All the chips back except A4.

Everything OK except A6 absent on H1

Everything ok except H5 absent. H5 back when A5 bypassed.

A5 and A6 absent on H10. A6 is back when A5 is bypassed.

A5 absent on H16

Everything OK. Noisy area in H9.

H9 absent, H16 absent, A3 to A6 absent on H15

H15 absent. OK when A2 is bypassed

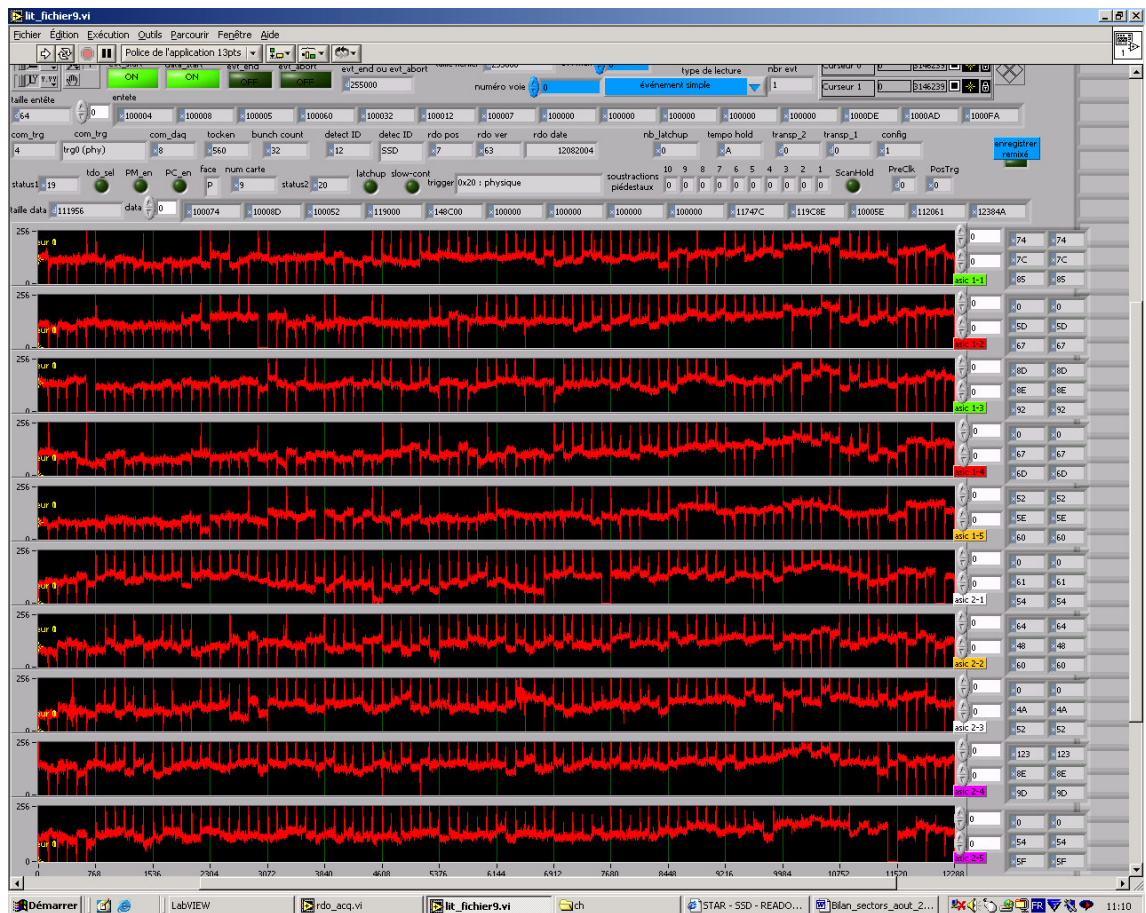
Sector 2P after the changes.

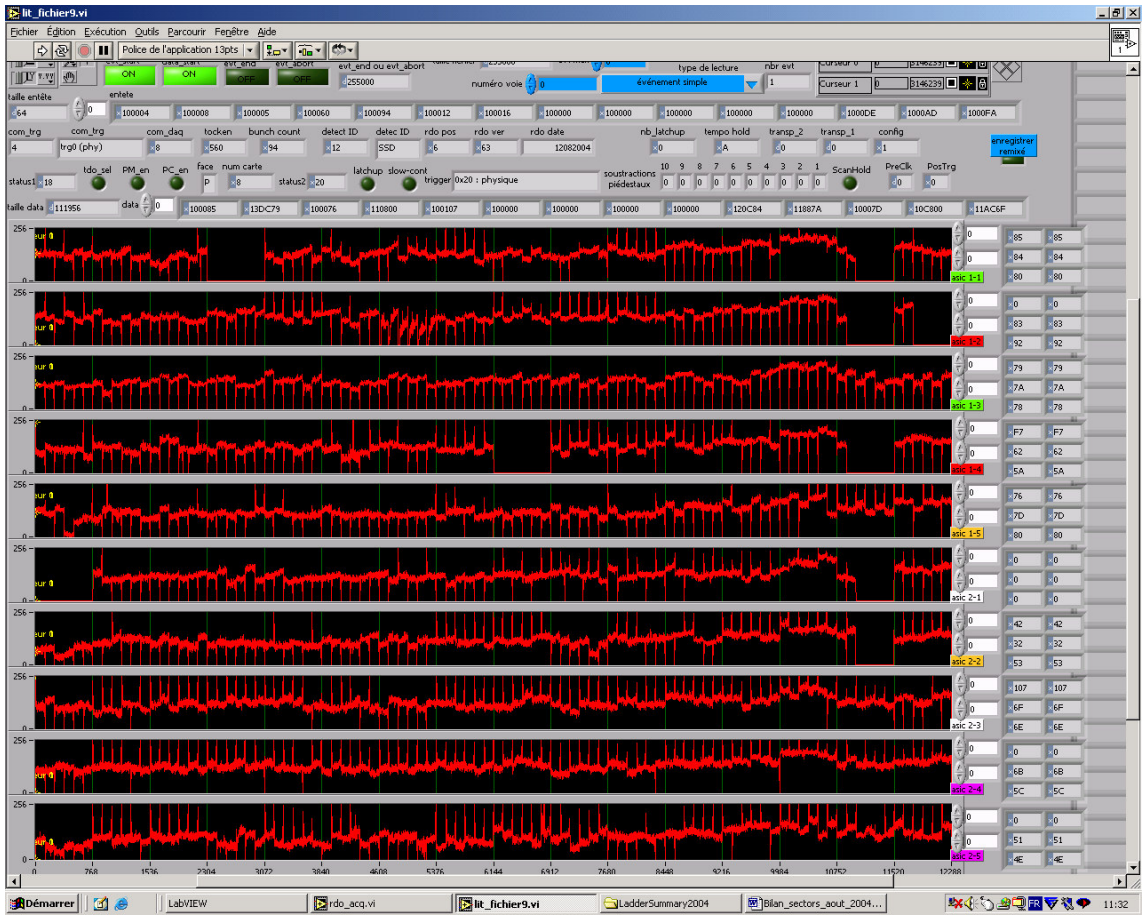
## Sector 1P (ladders 1P to 10P)

A3 to A6 missing on H15. OK with bias parameters changed

H1 missing. Still missing with force bias.

A2 to A6 missing on H15. OK with bias parameters changed

H9 missing. All chips back when A1 is bypassed.

A3 to A6 missing on H16. OK with bias parameters changed

The pedestal on H7 has a bad shape.

A3 to A6 missing on H15. OK with bias parameters changed except A1 with high ped. A1 is sometimes ok when it has its bias set to the nominal value

H4 missing. Back with force bias.
